BANK EROSION STUDY

Ohio River Division Field
OHIO RIVER BANK
EROSION STUDY.

OHIO RIVER
BANK EROSION STUDY

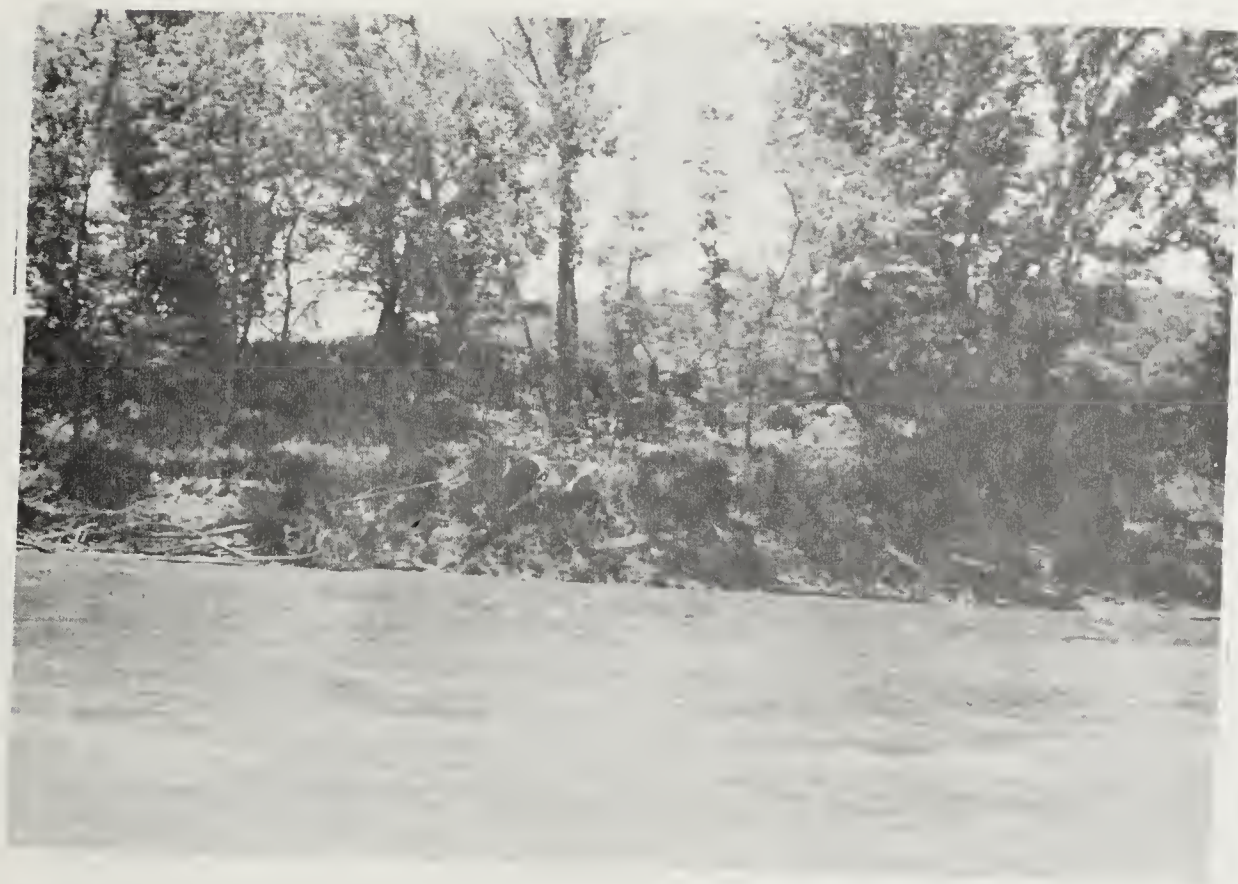
D

Area evidencing recent erosion in toe of slope area. Note bench within upper bank areas. 9 May 1977

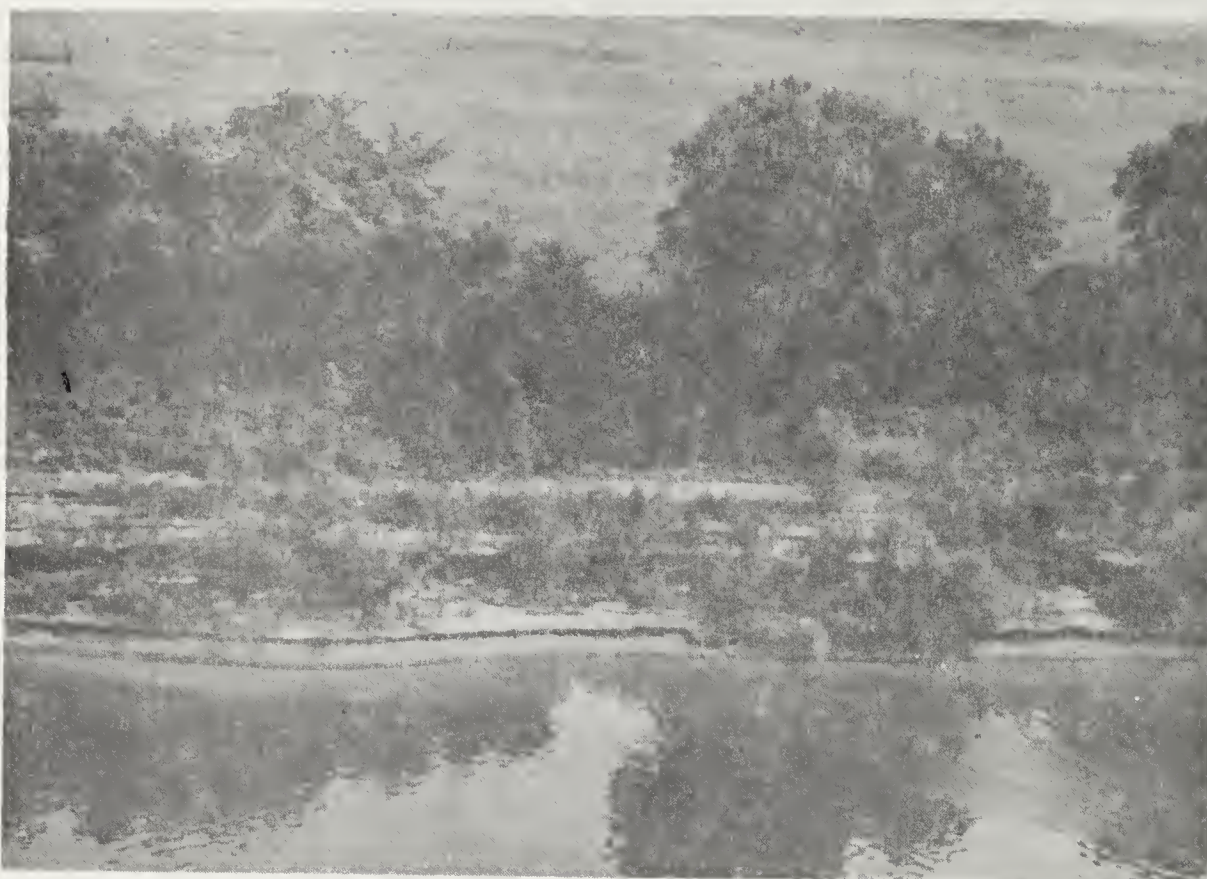
A

Sampling Site, 23 May 1977

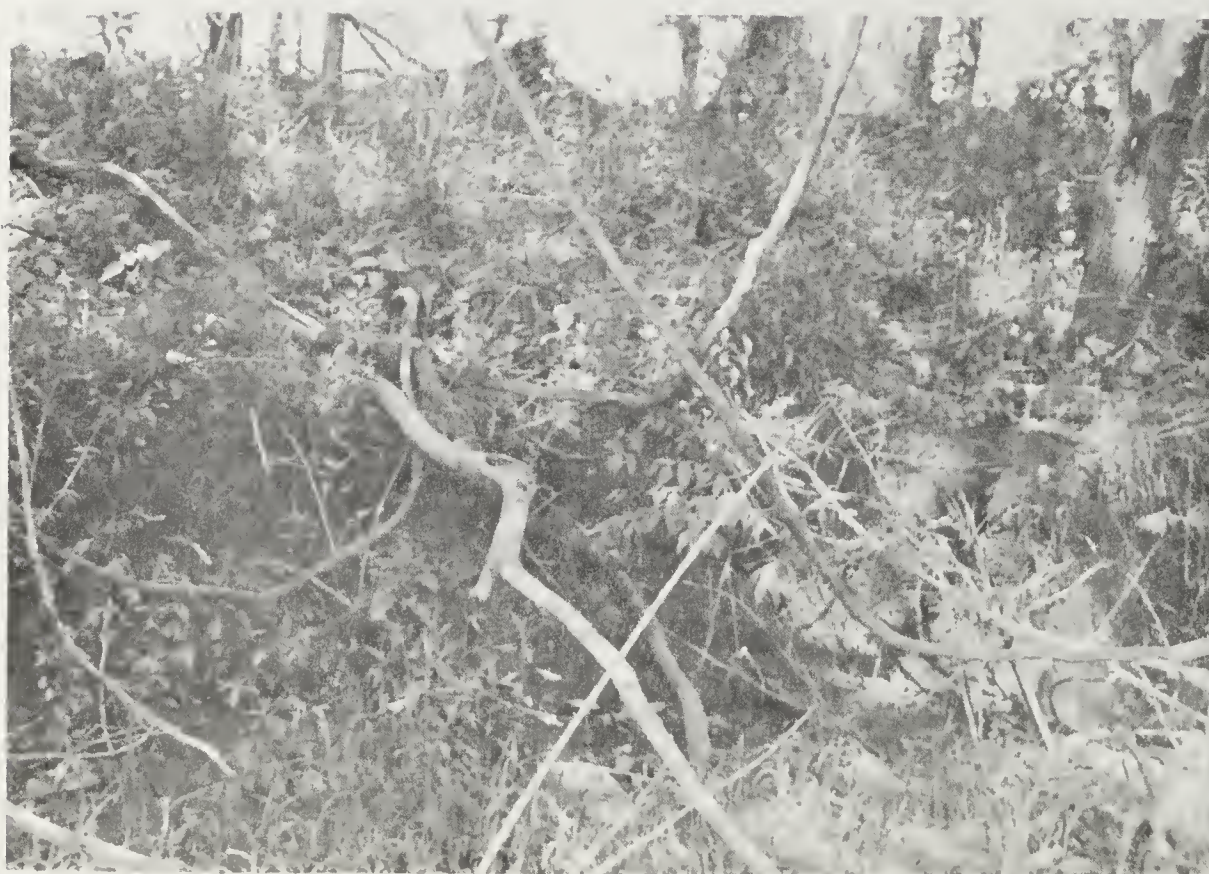
B

Bank near sampling site with slumpage scarp in foreground. 29 April 1977

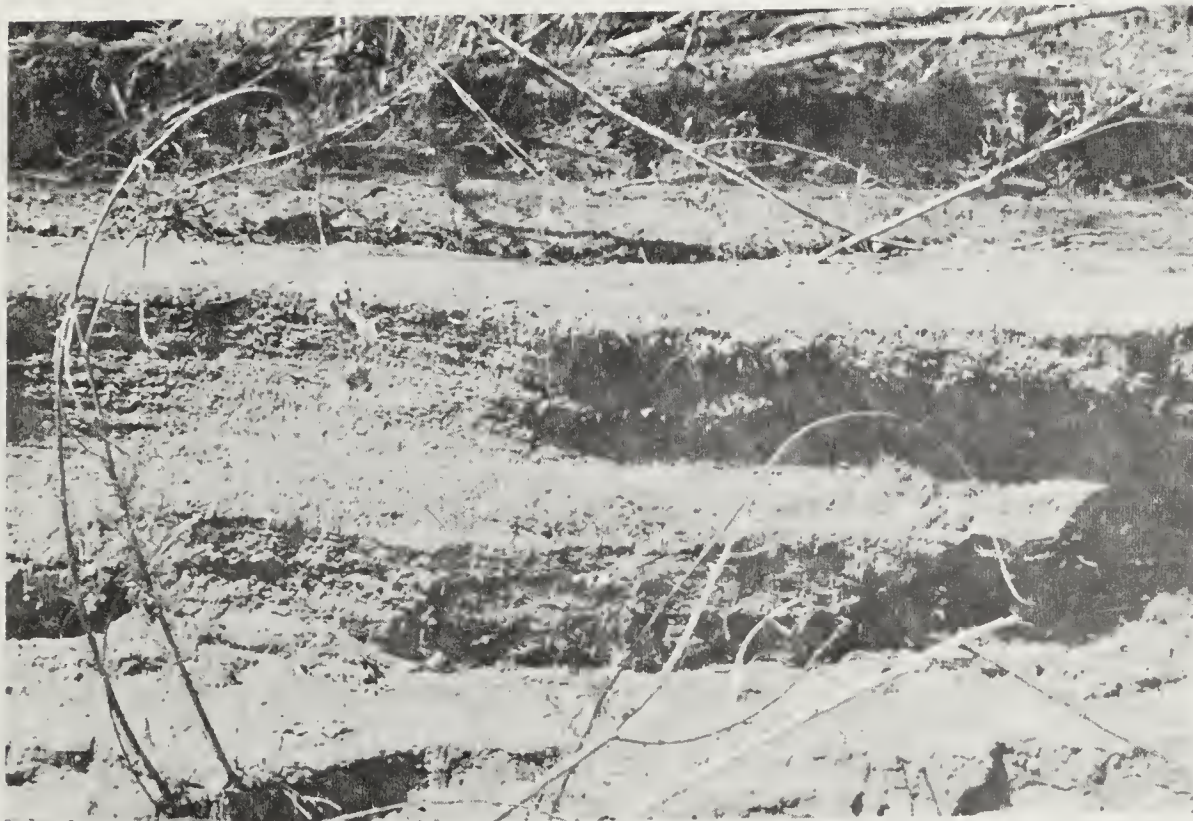
D

Lower portion of bank. Leaf fragments and multiple
small erosion scarps are evident. 29 April 1977

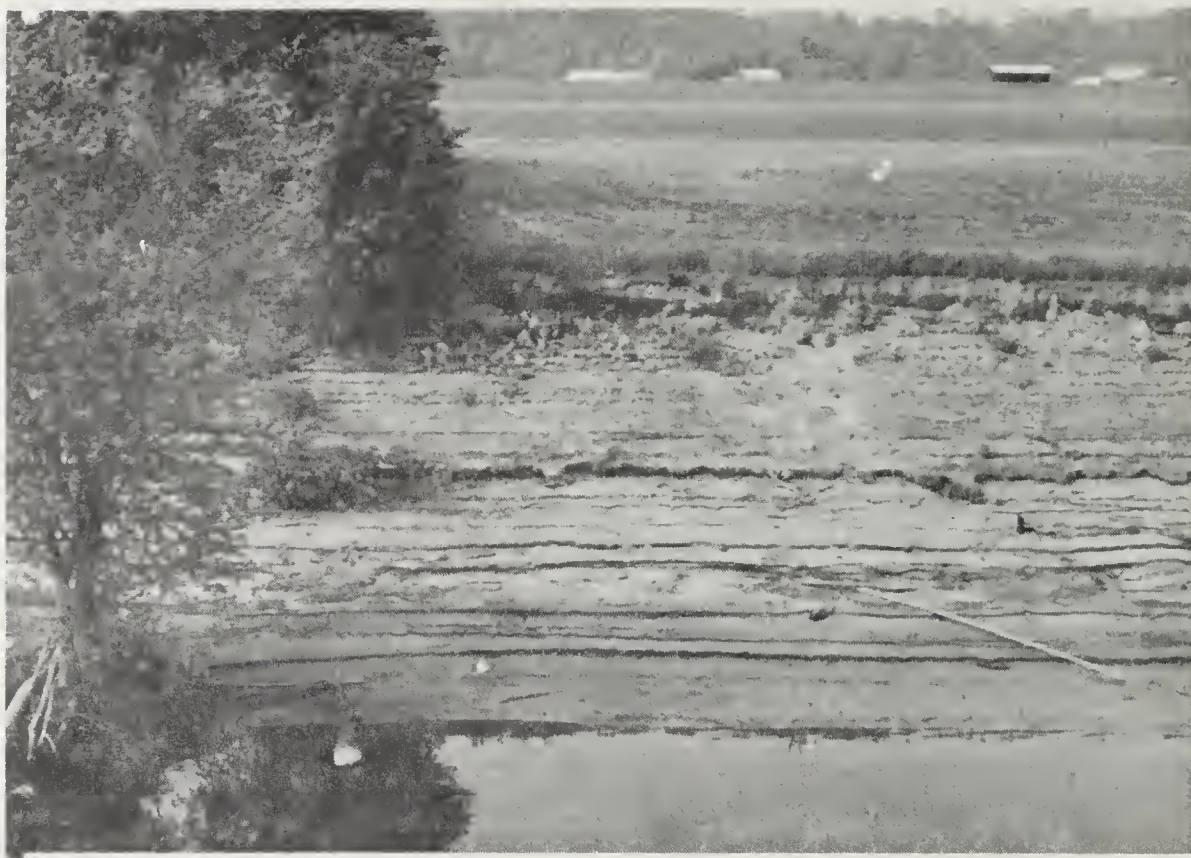
A

Sample site near upstream tract boundary. 23 May 1977

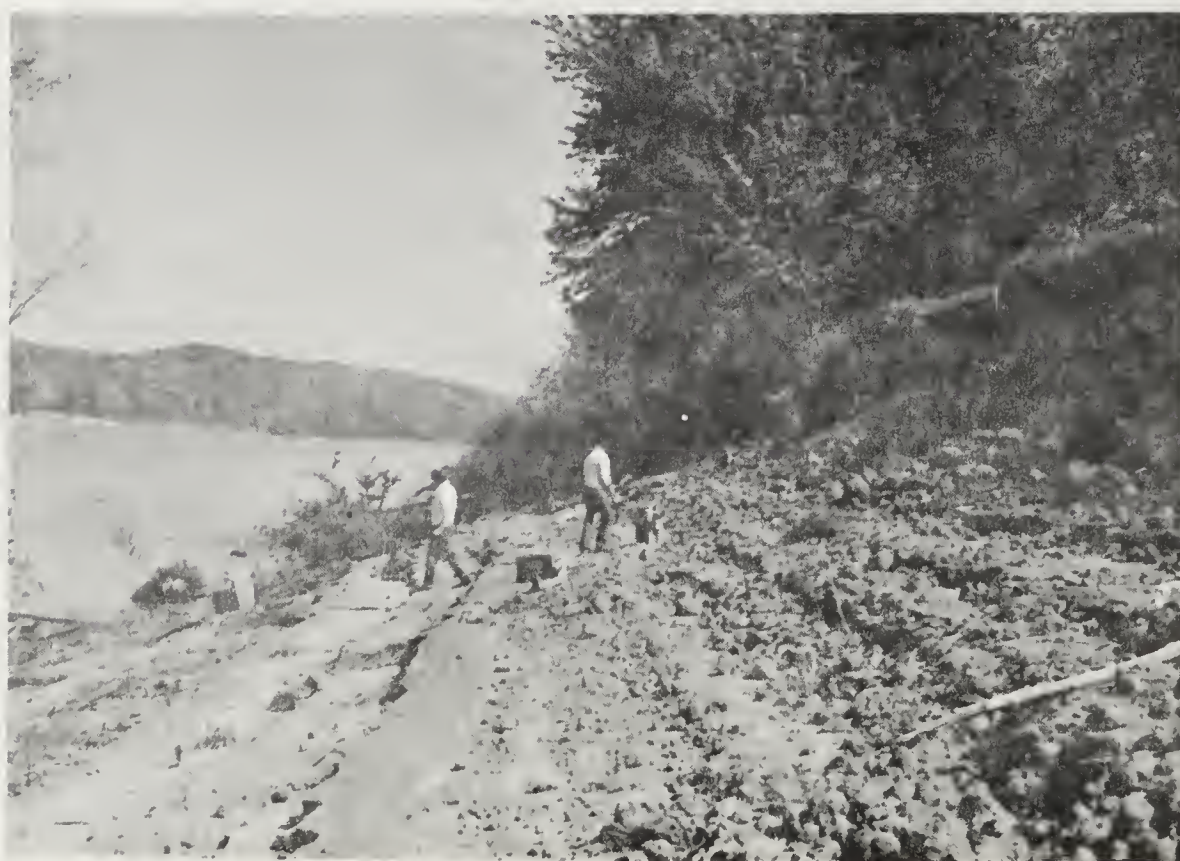
B

Benching of lower bank at sample site. 27 April 1977

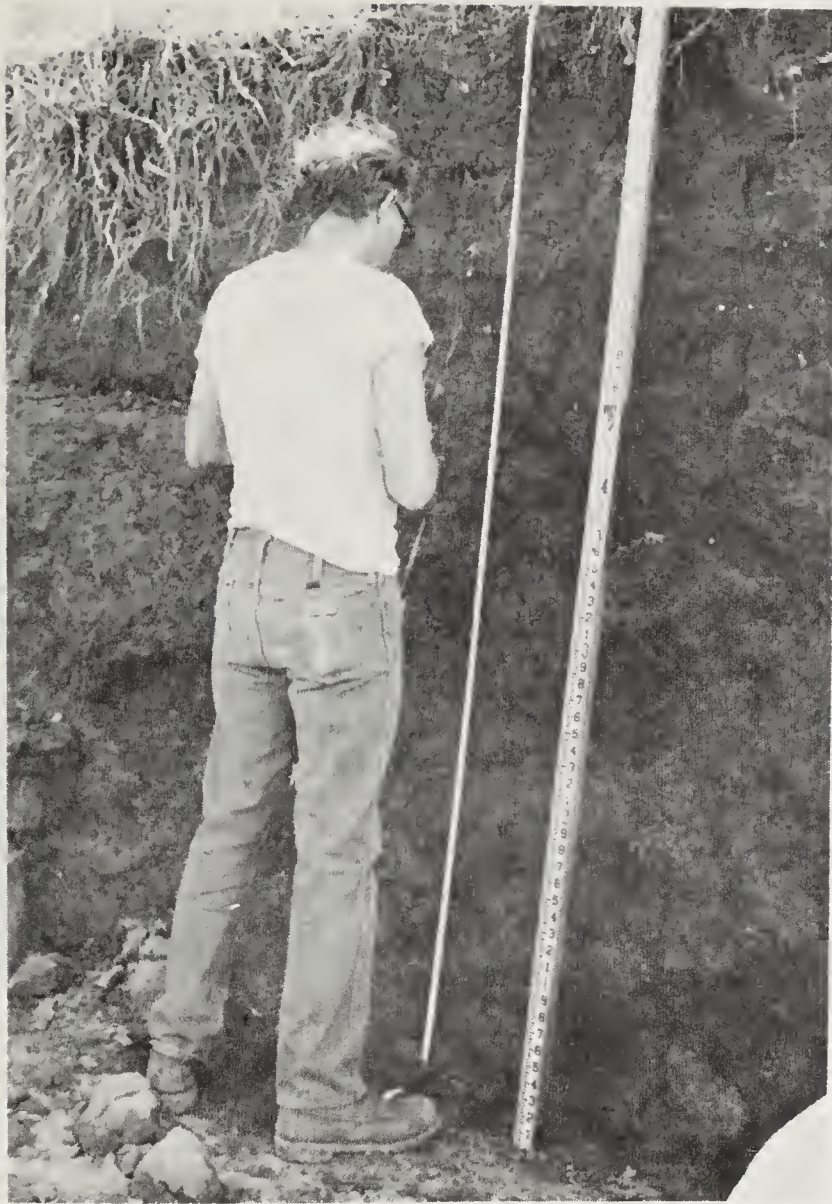
C

Logging and sampling near top of bank.
27 April 1977

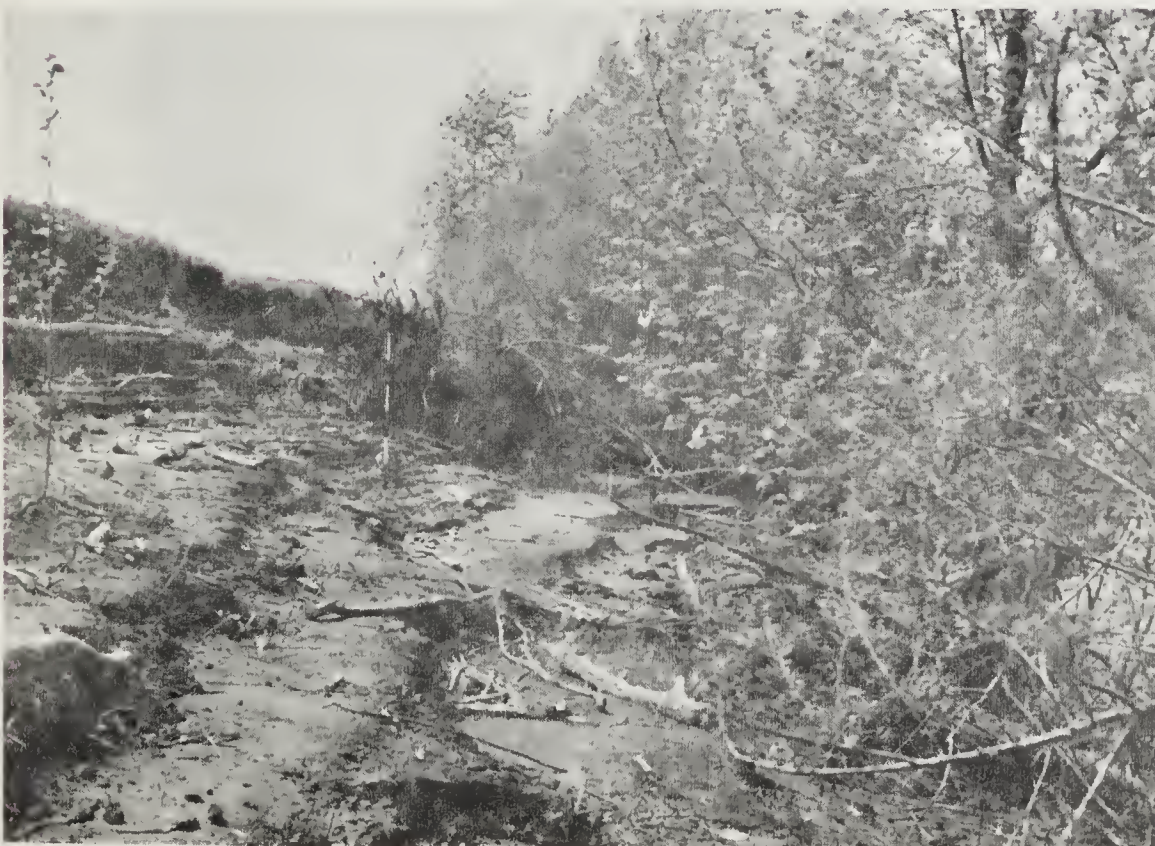
D

Recent benching of bank area. 27 April 1977

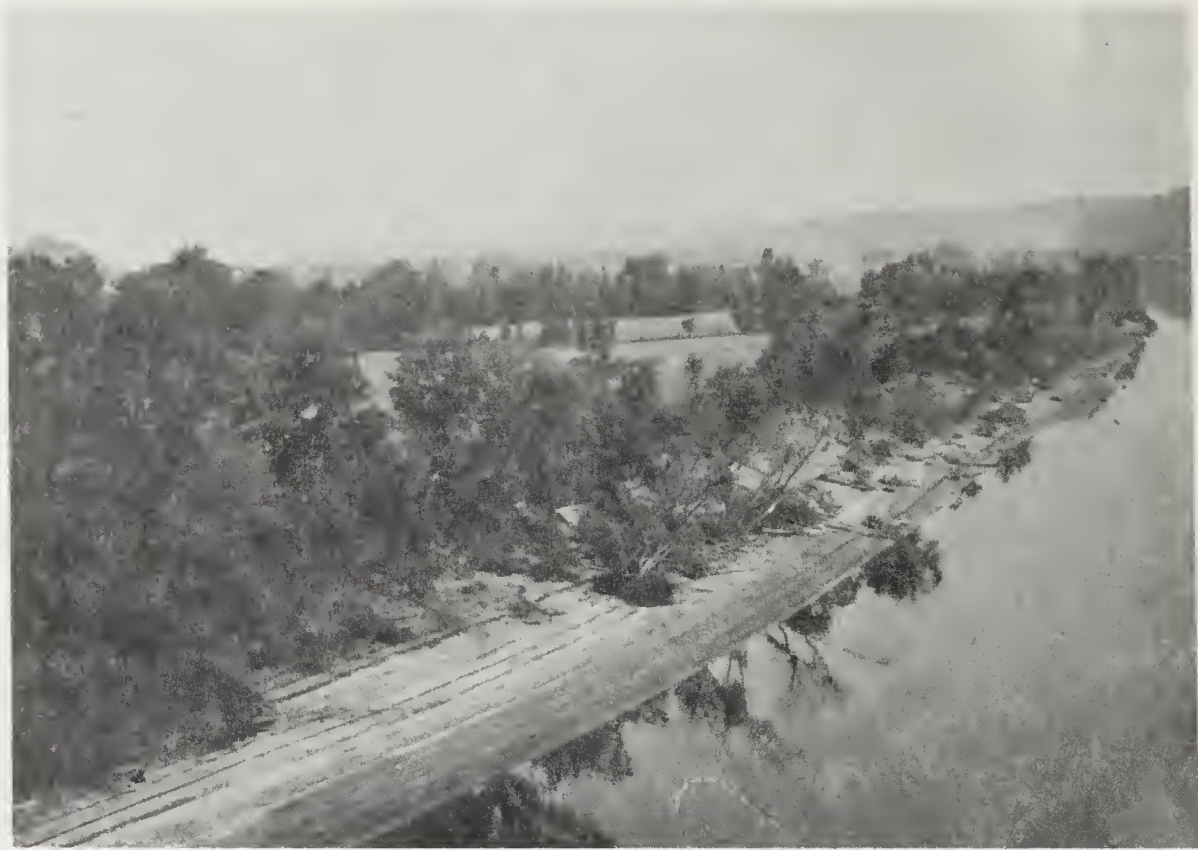
A

Looking downstream along J. H. McGehee Property.
23 May 1977

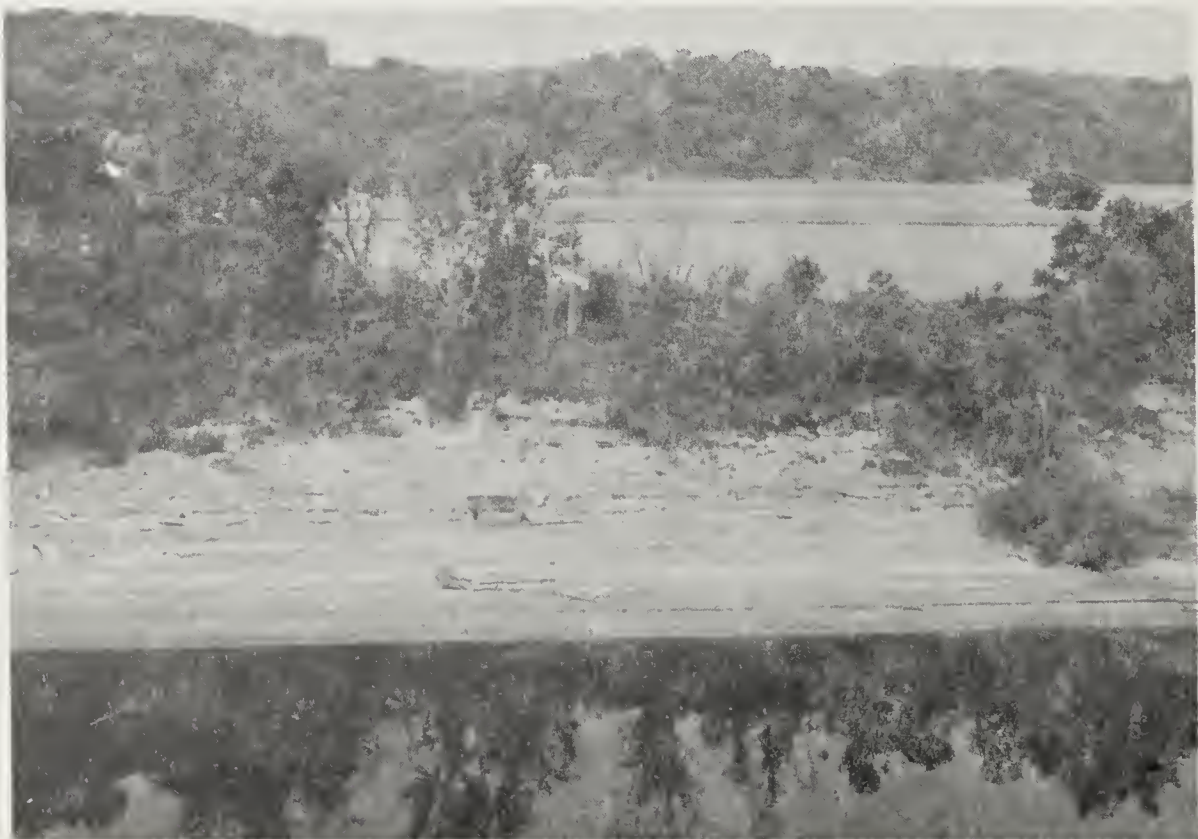
B

Area of transition from granular to fine-grained bank
materials. 23 May 1977

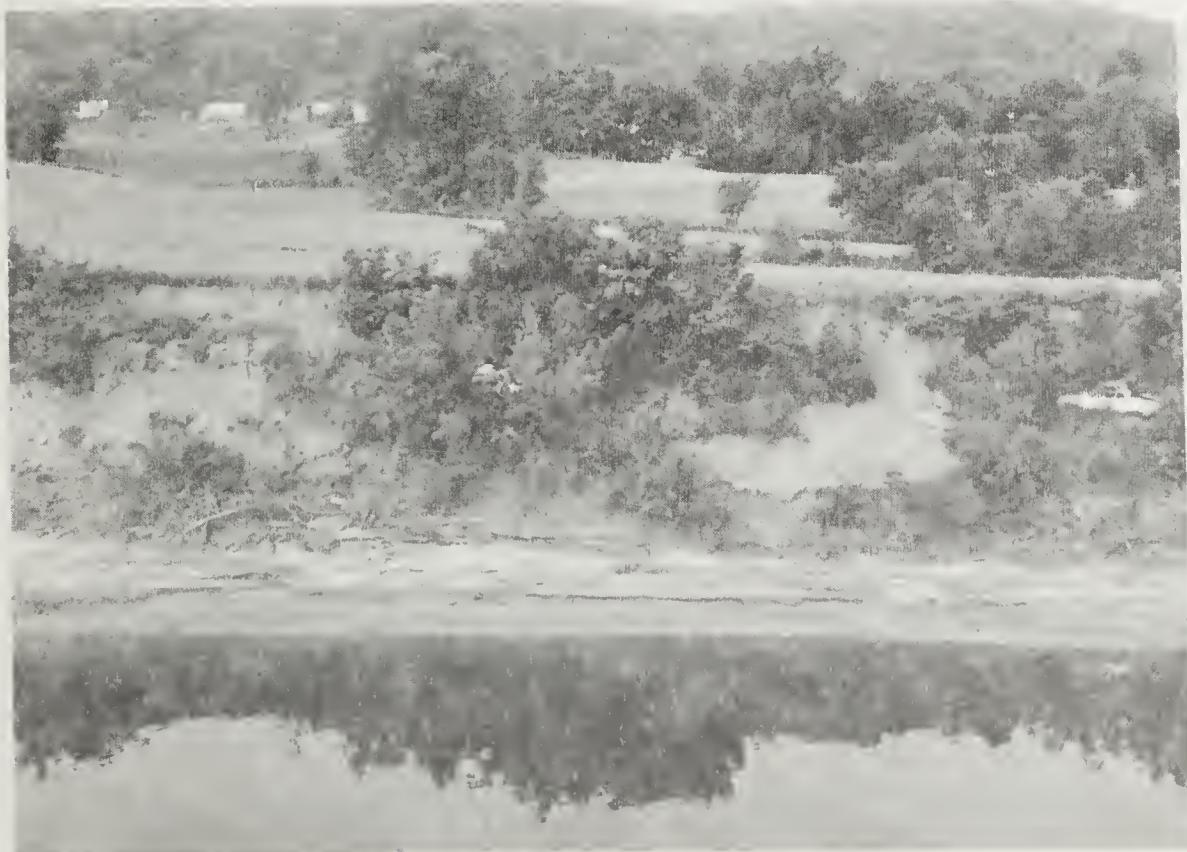
D

Narrow beach downstream of sampling site. Note dense gray silt exposed at lower right. 23 May 1977

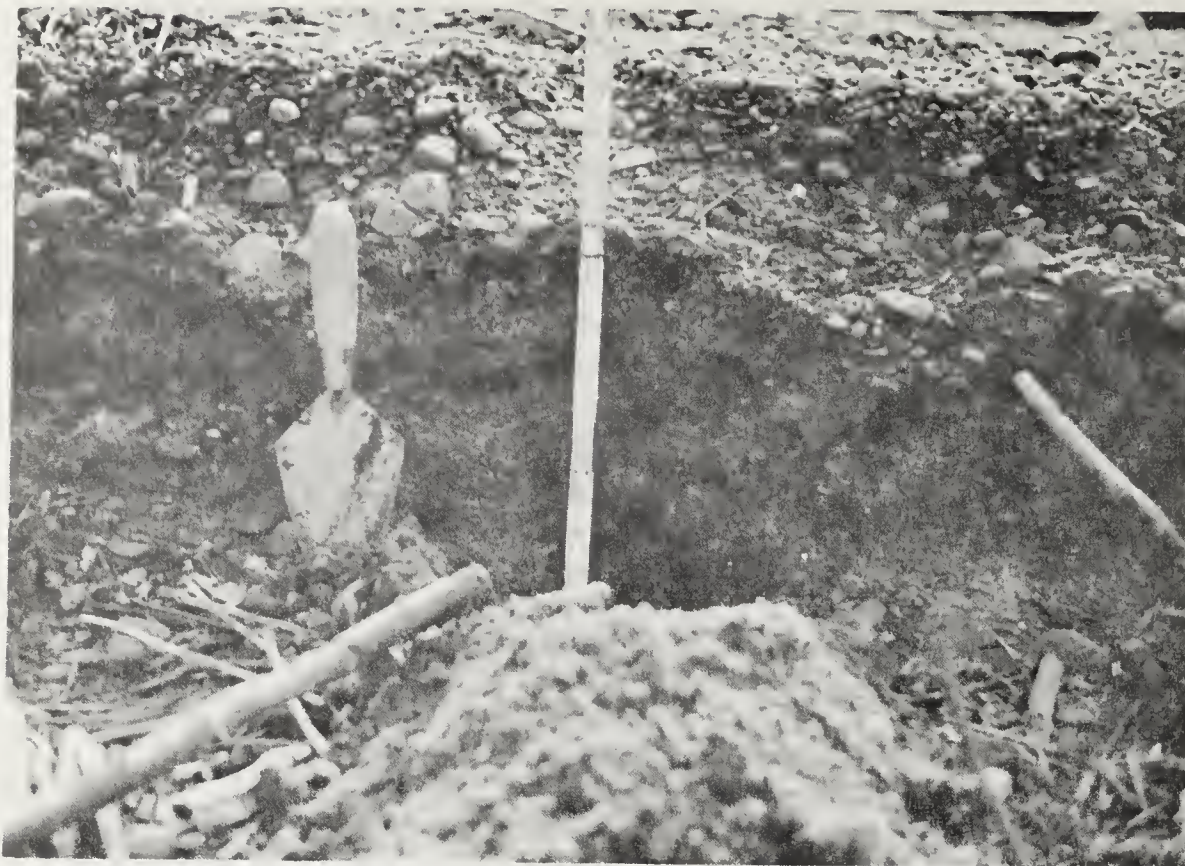
E

Fresh erosion scarp showing stratified sand, silt
and gravel. 5 May 1977

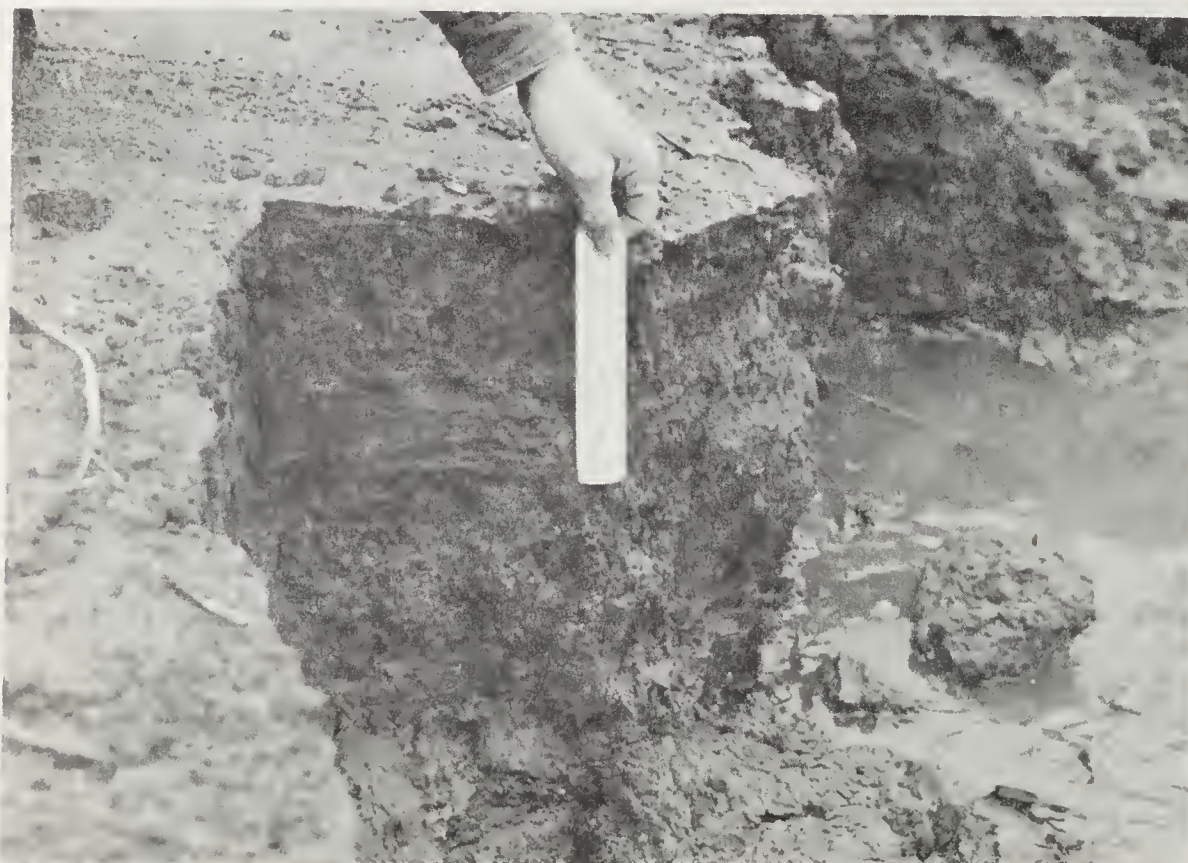
F

Fresh erosion scarp evidencing stratification.
29 April 1977

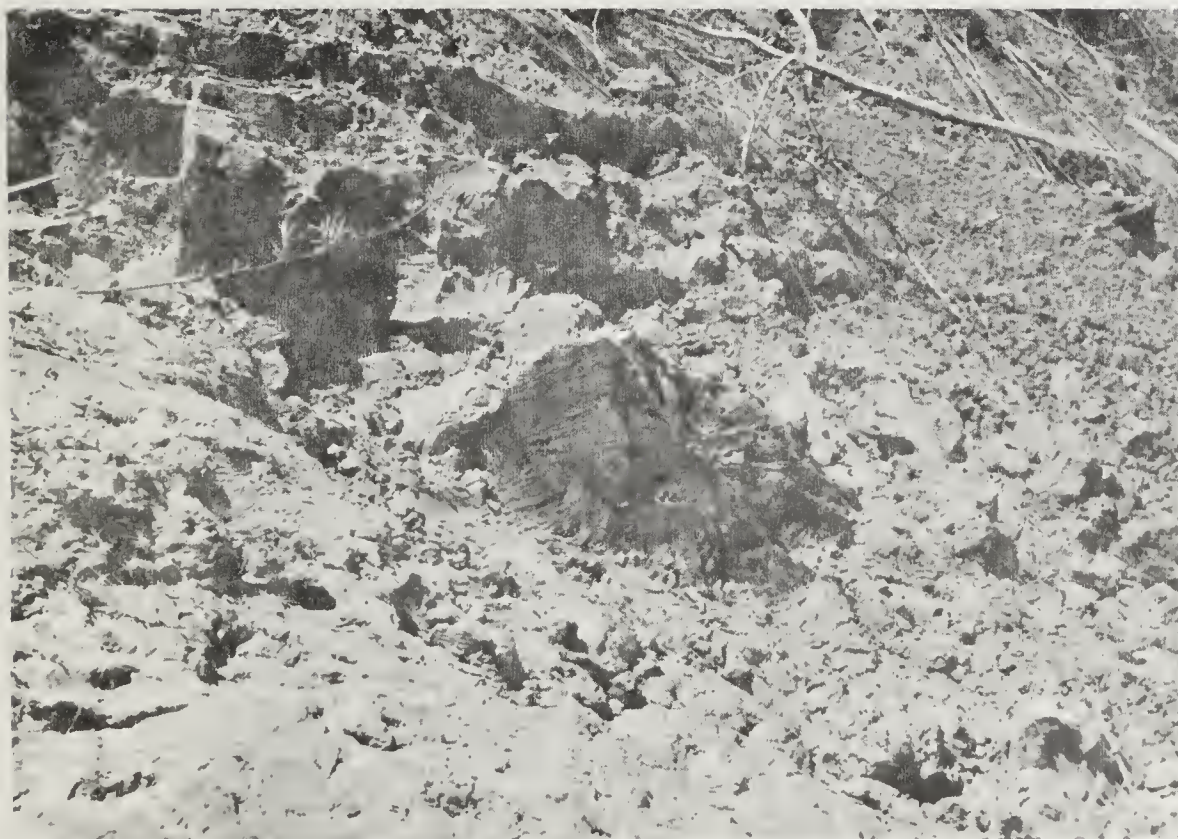
H

Butt end of buried log in dense gray silt. Log was
buried approximately 7,000 years B. P. 29 April 1977

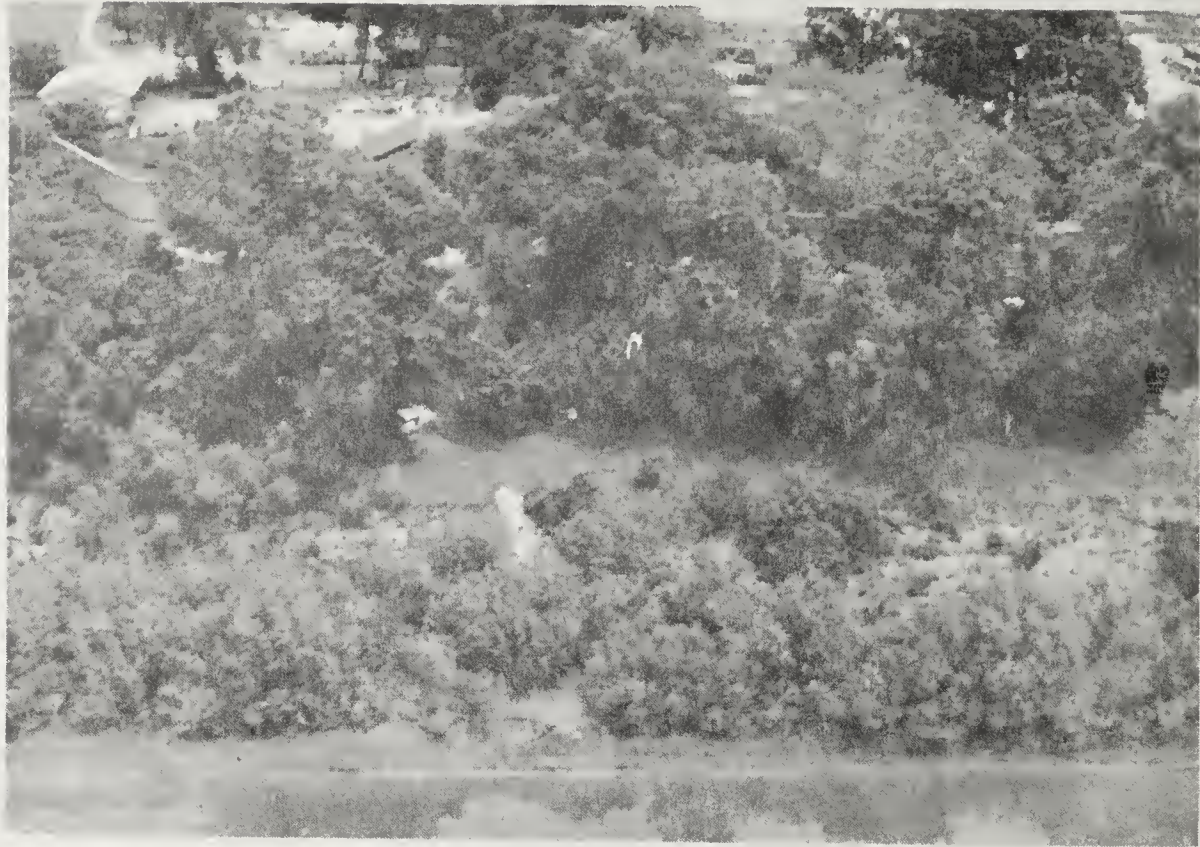
A

Dickenson Property and portions of adjacent tracts.
23 May 1977

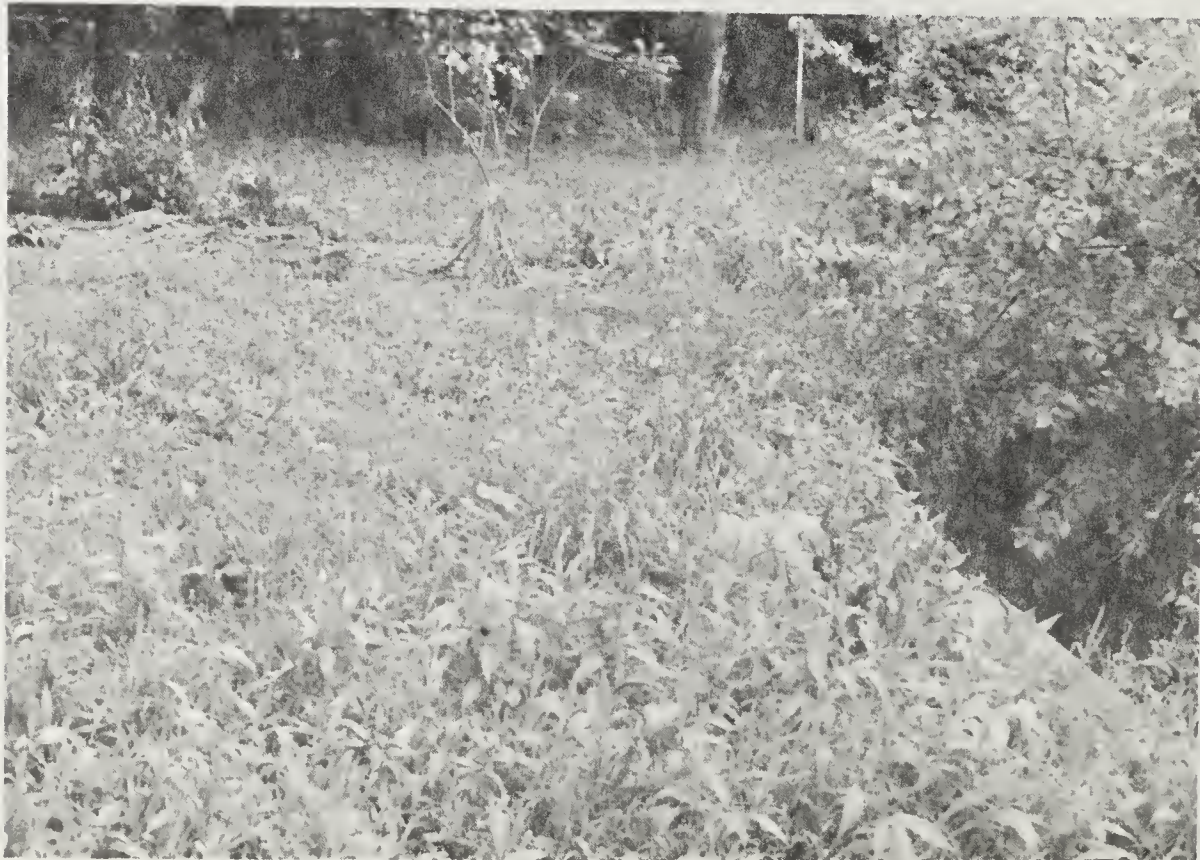
B

Looking upstream along top of bank. Weeds at left
mark sewage seepage which could be related to area of
deepest bank erosion as located at right. 3 May 1977

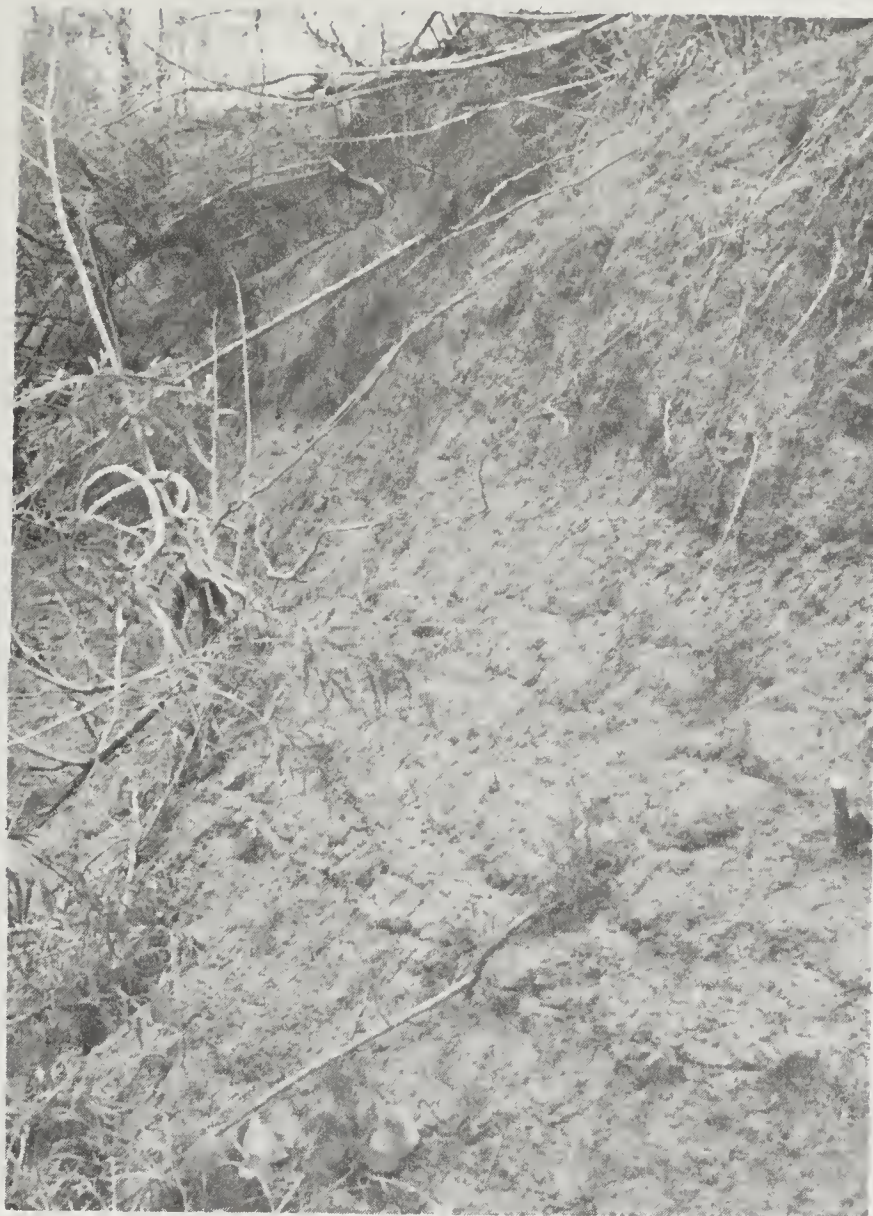
C

Bank area immediately downstream of
sampling site. 3 May 1977

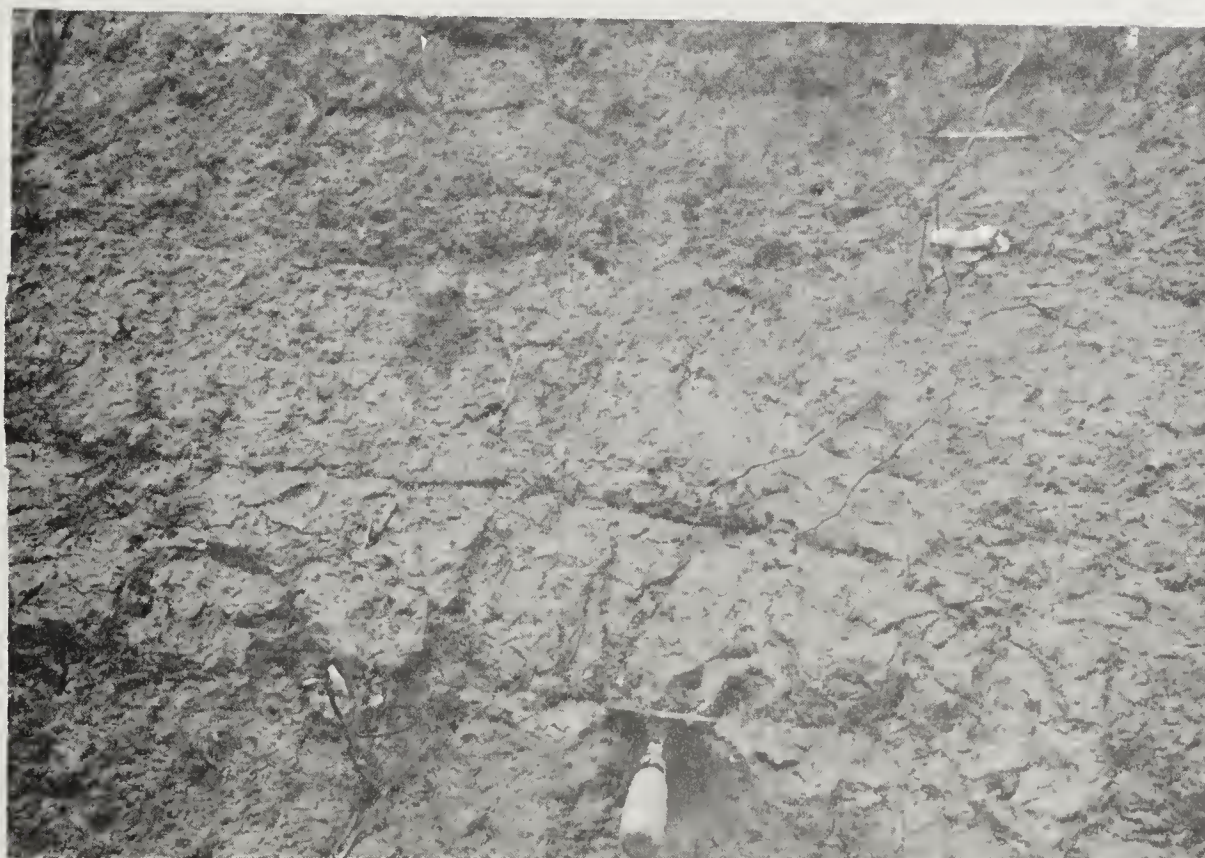
D

Layers of coal fragments within bank at paper and
trowel levels (10.3' and 11.4' below top of bank,
respectively) 3 May 1977
